9754
1894

Tool and Bolt

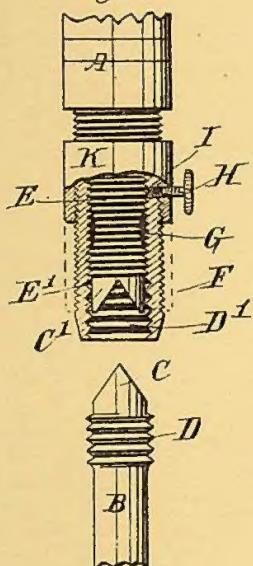
Fig. 1.

Threads of diff.
pitch cause
jamming between
tool shank B and
bolt E.
